Manhole Inspection Summary

Manhole # S69G1_003MH

Insp Date: **2/25/08 12:55 PM**

Location Address: **2700 Broening Hwy.**

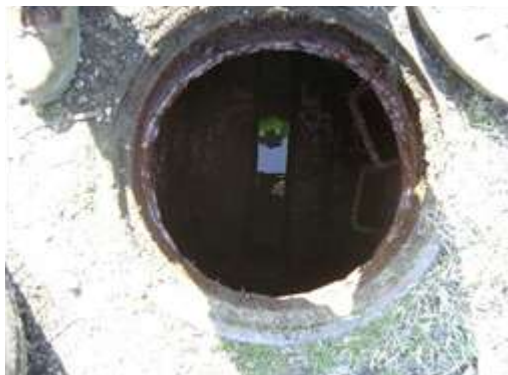
Defect 3

Frame Offset: **2** (in.) Condition: ☒ Sound ☐ Cracked ☐ Leaks

Frame offset

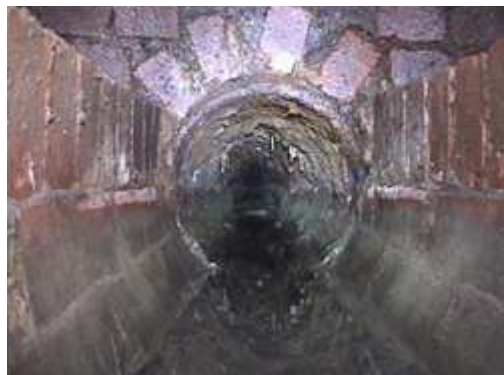
Defect 2

minerals encrusted deposits in pipe
incoming 6 o'clock

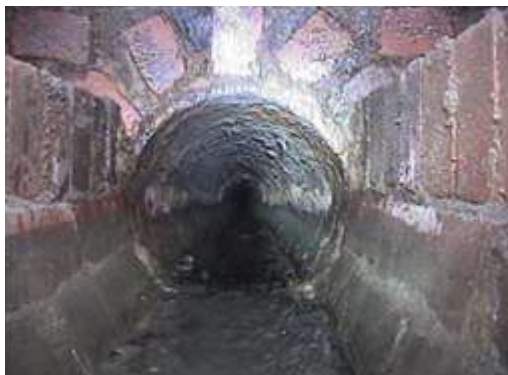
Defect 1

minerals encrusted deposits in pipe
outgoing 12 o'clock

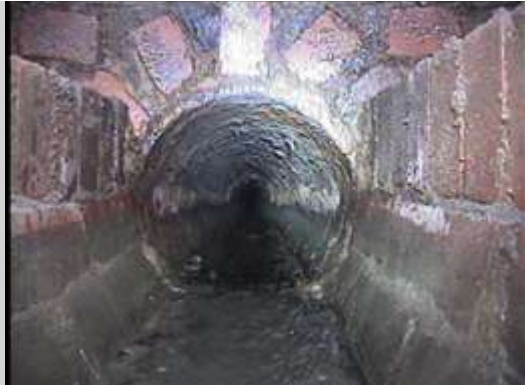
12 O'Clock Outflow

10 in. Circular Gravity Sewer
Pipe Out @ 12 O'Clock

Pipe Height: **10.8** (in.) Rod and Bar (Angled)
Pipe Material: **Clay** ☐ Pipe Lined
Invert Depth: **7.46** (ft.) Flow Characteristics: **Fast**
Deposits: ☒ None ☐ Mud ☐ Sludge ☐ Debris ☐ Grease
Silt Depth: (in.) Deposits Extent:
Infiltration: **None** Pipe Seal Cond: **Sound**

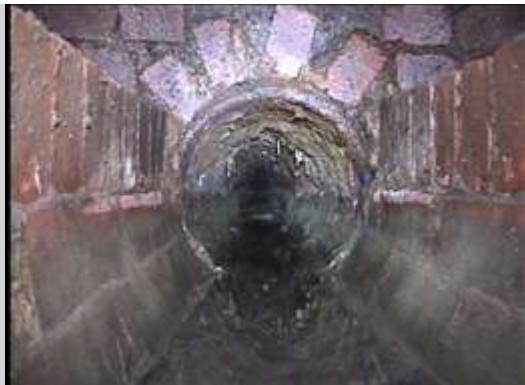
6 O'Clock Inflow

10 in. Circular Gravity Sewer
Pipe In @ 6 O'Clock

Pipe Height: **10.8** (in.) Rod and Bar (Angled)
Pipe Material: **Clay** ☐ Pipe Lined
Invert Depth: **7.42** (ft.) Flow Characteristics: **Fast**
Deposits: ☒ None ☐ Mud ☐ Sludge ☐ Debris ☐ Grease
Silt Depth: (in.) Deposits Extent:
Infiltration: **None** Pipe Seal Cond: **Sound**
